City of Greater Geraldton
Municipal Inventory of Heritage Places
Place Record

Area: Geraldton	Place Number: 141	Category: 3
Assessment Date: 15/10/1996	Last Revision Date: 03/11/2009	
HCWA Number: 13391	Asset ID: MCH127107

Name:	House
Other Names:	83 Fitzgerald Street
Type of Place:	House
Address:	83 Fitzgerald Street
Suburb:	Geraldton

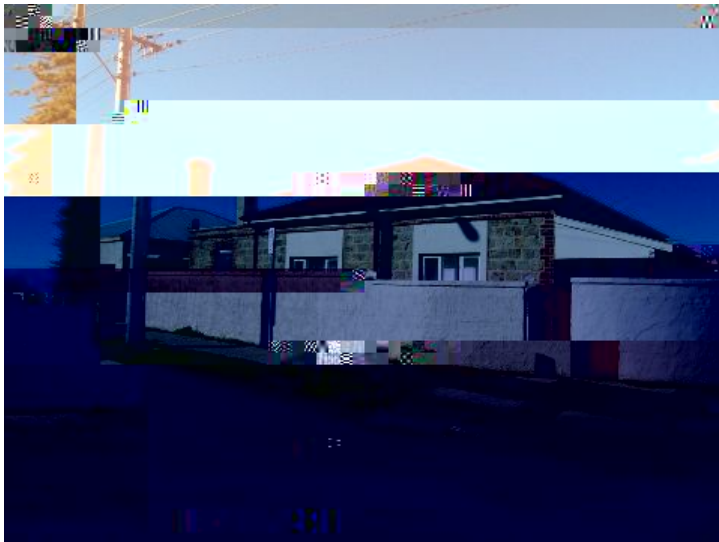
Photo Description:
26/06/2009
Tanya Henkel
Stone house set behind a tall rendered wall.

Walls:	Stone	Roof:	Comugated Iron
Condition:	Good	Integrity:	
Original fabric:	Highly intact		
Modifications:	New entry door

Located on the corner of Augustus Street, this stone house has a hipped comugated iron roof with a separate verandah to the front (west) elevation which is supported on timber posts. To the rear there is a skillion roof with a tall corbelled chimney. The stonework is coursed with brick quoining to the original openings and corners of the building. The timber windows are a mixture of original double hung and casement. The house is set behind a tall rendered masonry wall which largely obscures the view to it from the street.

Management Category:	3
Level of Significance:	MODERATE SIGNIFICANCE: Important to the heritage of the locality.
Management Recommendation:	Conservation of the place is recommended. Any proposed change to the place should not unduly impact on the heritage values of the place and should retain significant fabric wherever feasible.
