City of Greater Geraldton
Municipal Inventory of Heritage Places
Place Record

Name:	House
Other Names:	93 Gertrude Street
Type of Place:	House
Address:	93 Gertrude Street
Suburb:	Geraldton

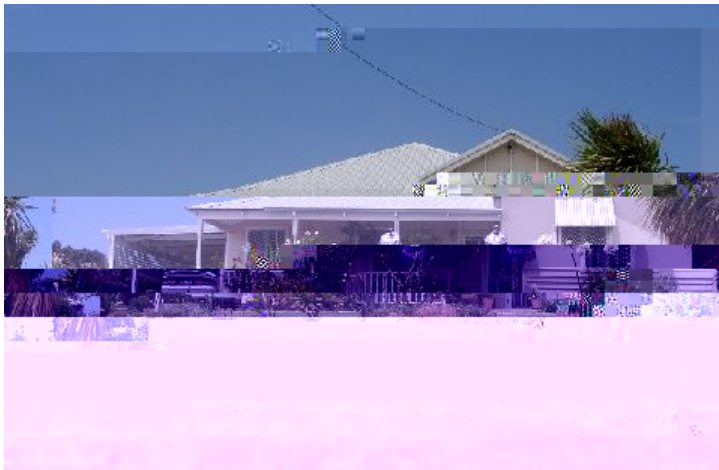
Photo Description:
14/11/2007
Rod Milne
Set above the street level

This timber framed house has a hipped zincalume roof with broken back extensions which cover the verandahs to the front (west) and north. To the rear there is a lean-to roof and to the south west a separate gable roof covers the main room. The house is clad with weatherboard to window sill height with fibro above and fibro and timber batten to the gable end. The front verandah is supported on timber posts with a timber balustrade between. The north verandah is enclosed with weatherboard below and windows above. The windows to the gable and south side have corrugated iron awnings. There is a small brick chimney to the north east and a carport with a lean-to roof is attached to the north side.

Management Category:	4
Level of Significance:	SOME SIGNIFICANCE: Contributes to the heritage and/or historical development of the locality.
Management Recommendation:	Conservation of the place is desirable. Any proposed change to the place should be in sympathy with the heritage values of the place.
