City of Greater Geraldton  
Municipal Inventory of Heritage Places  
Place Record

Name:	House
Other Names:	79 Gregory Street
Type of Place:	House
Address:	79 Gregory Street
Suburb:	Beachlands

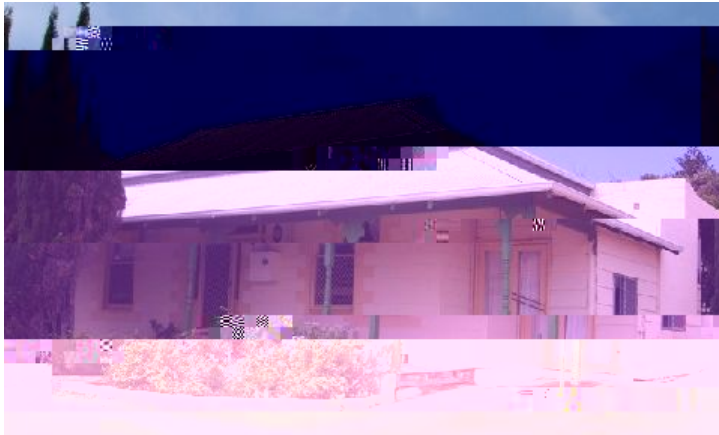
Photo Description:  
14/11/2007

Walls:	Concrete Block	Roof:	Comugated Iron
Condition:	Good	Integrity:	
Original fabric:			
Modifications:	Box awning to front

Set close to the street boundary, this painted concrete block house has a comugated iron gambrel roof. A separate hipped roof covers a verandah to the front and a fibro enclosed area to the south. The front verandah is supported on tuned timber posts which have decorative fretwork brackets. The front facade has contrasting paint treatment which highlights the quoining to the doorway and windows which are timber framed and double hung.

Management Category:	3
Level of Significance:	MODERATE SIGNIFICANCE: Important to the heritage of the locality.
Management Recommendation:	Conservation of the place is recommended. Any proposed change to the place should not unduly impact on the heritage values of the place and should retain significant fabric wherever feasible.
