City of Greater Geraldton  
Municipal Inventory of Heritage Places  
Place Record

Name:	House
Other Names:	86 Sanford Street
Type of Place:	House
Address:	86 Sanford Street
Suburb:	Geraldton

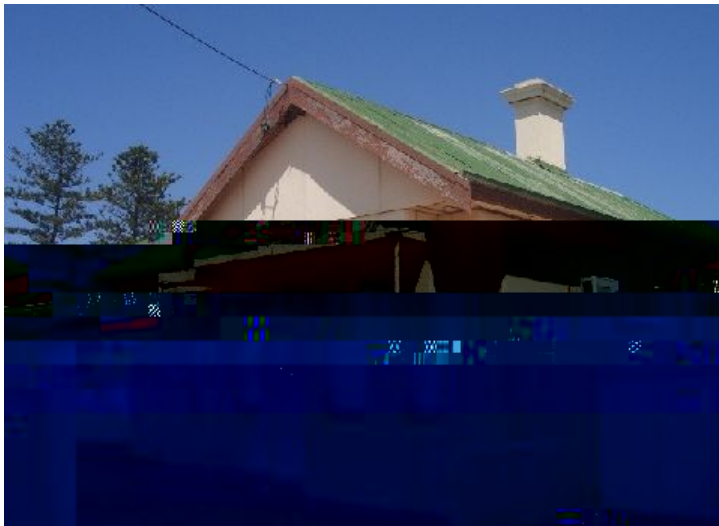
Photo Description:  
15/01/2008  
Rod Milne  
Feature quoining to corners.

This painted concrete block house has a hipped comugated iron roof with a separate gable to the front (south) and a separate flat concrete verandah roof supported on metal posts. The gable end which covers a bay, is clad with fibro. The comers to the front of the building are quoined. Windows are timber framed and double hung. To the west, there is an enclosed exte: : : ° ou isrs w a a q a i q a c

Management Category:	3
Level of Significance:	MODERATE SIGNIFICANCE: Important to the heritage of the locality.
Management Recommendation:	Conservation of the place is recommended. Any proposed change to the place should not unduly impact on the heritage values of the place and should retain significant fabric wherever feasible.
