City of Greater Geraldton
Municipal Inventory of Heritage Places
Place Record

Area: Geraldton	Place Number: 158	Category: 4
Assessment Date: 15/10/1996	Last Revision Date: 18/11/2009	
HCWA Number: 13408	Asset ID: MCH127021

Name:	House
Other Names:	141 Fitzgerald Street
Type of Place:	House
Address:	141 Fitzgerald Street
Suburb:	Geraldton

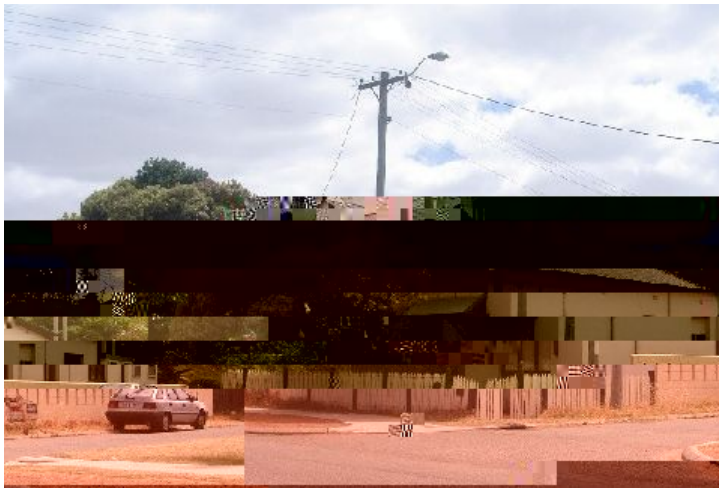
Photo Description:
6/12/2007
Rod Milne
Corner location.

This painted concrete block house has a comugated iron gambrel roof with a separate gable roof to the front main room and a skillion roof to the rear with a fibro clad extension beyond. The gable end has fibro and timber batten infill with a metal awning to the window below. A separate verandah roof is supported on timber posts. Windows are timber framed double hung and casement in style. There is a corbelled brick chimney and the street boundary has a picket fence to the west and painted concrete block wall to the south.

Management Category:	4
Level of Significance:	SOME SIGNIFICANCE: Contributes to the heritage and/or historical development of the locality.
Management Recommendation:	Conservation of the place is desirable. Any proposed change to the place should be in sympathy with the heritage values of the place.

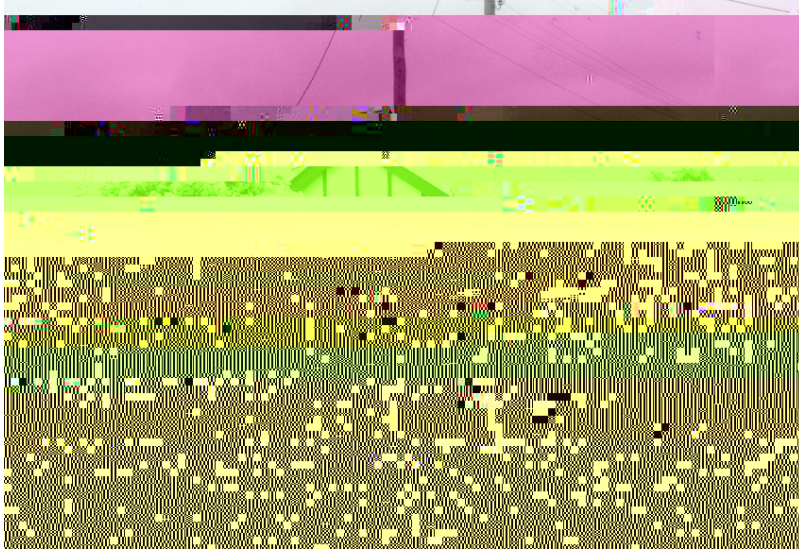
Photo Description:
15/10/1996
Suba & Grundy
Picket fence forms the property frontage.
