City of Greater Geraldton  
Municipal Inventory of Heritage Places  
Place Record

Area: Geraldton	Place Number: 32	Category: 4
Assessment Date: 25/10/1996	Last Revision Date: 10/07/2009	
HCWA Number: 13224	Asset ID: MC H126997

Name:	House
Other Names:	7 Burges Street
Type of Place:	House
Address:	7 Burges Street
Suburb:	West End

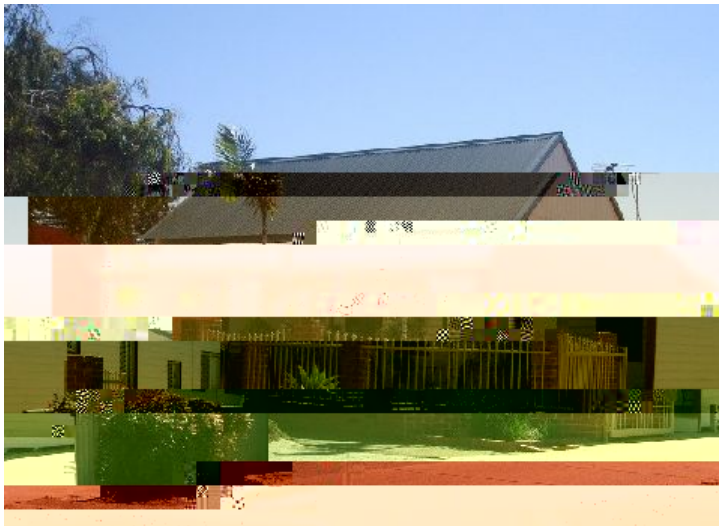
Photo Description:  
31/10/2007  
Rod Milne  
View of the house from Burges Street.

Walls:	Weatherboard/Vinyl	Roof:	Colorbond
Condition:	Good	Integrity:	
Original fabric:			
Modifications:	Vinyl cladding to side elevations

This small timber framed cottage has a steeply pitched colorbond gable roof. Vertical weatherboarding is used to enclose the gable ends. Original weatherboard cladding remains to the front elevation while it has been replaced on the sides with vinyl cladding. There is a skillion roof to the rear and a separate bullnose verandah roof to the front. The verandah is supported on turned timber posts. To the front facade the windows are timber framed and double hung, while other windows have been replaced with aluminium frames.
